310 QUADRAL DRIVE WADSWORTH, OHIO 44281 (330) 334-0066					
		TITLE TIE-IN REPAIR					
SCALE	NONE	DWN	PBF	CHK	BS	APPROVAL DATE	8/11/09
DRAWING NUMBER	M-6					REV	0

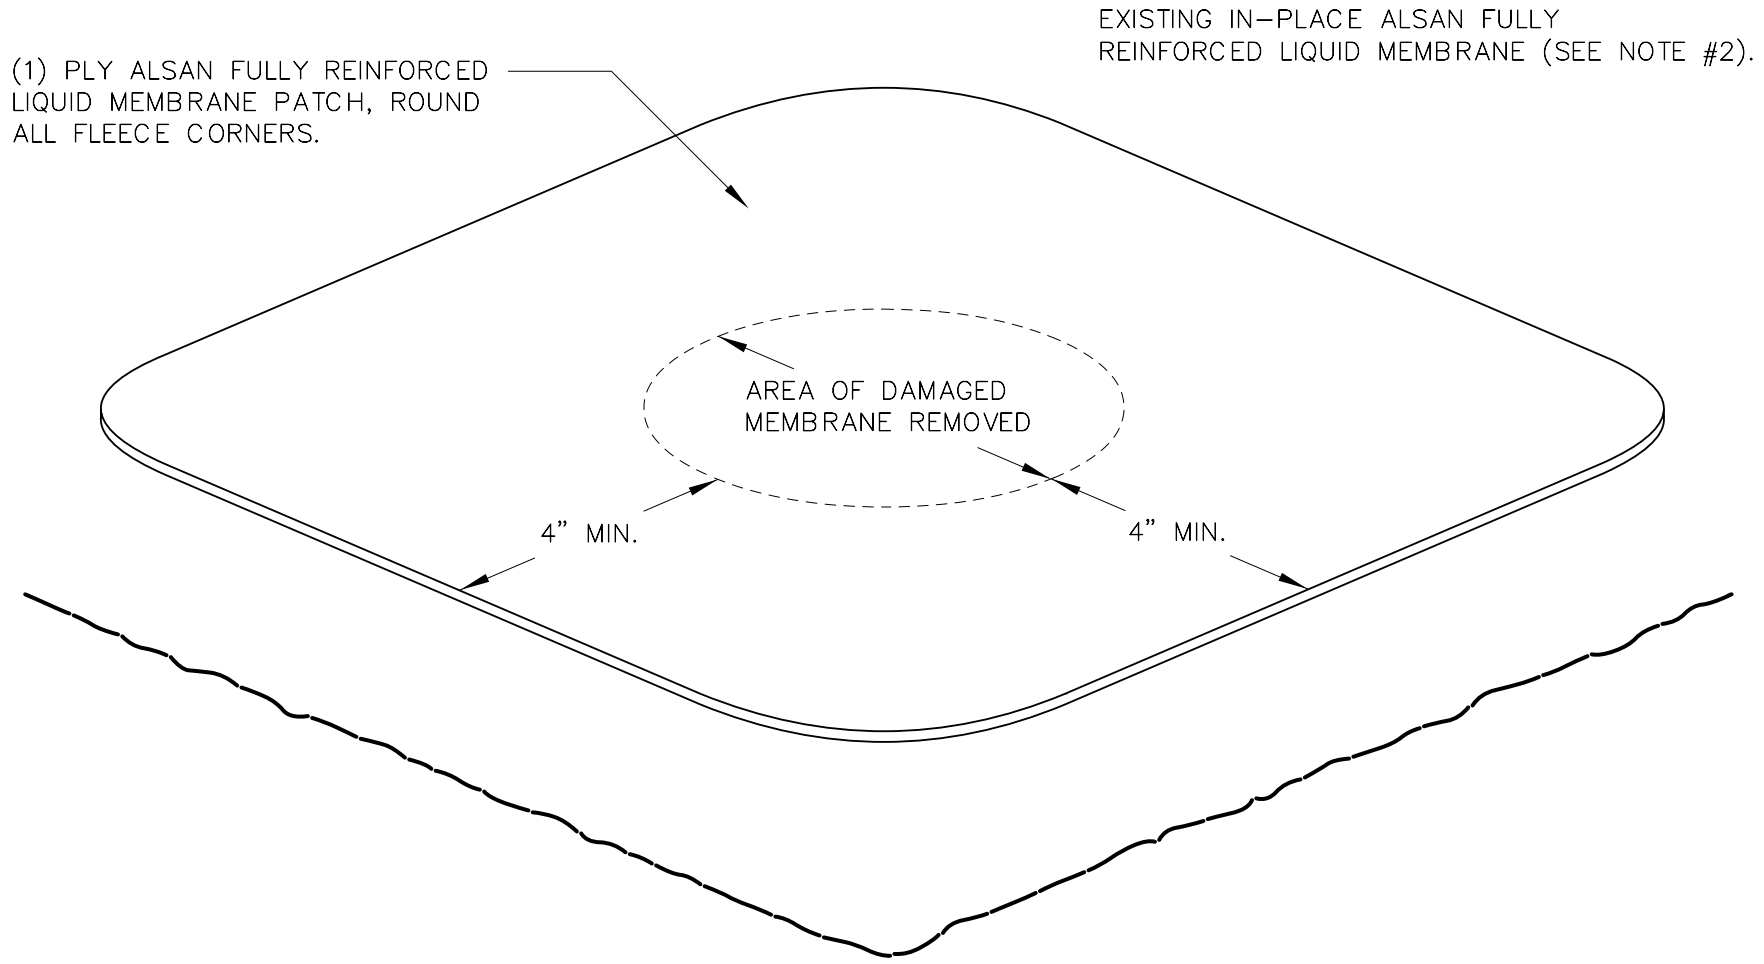
(1) PLY ALSAN FULLY REINFORCED LIQUID MEMBRANE PATCH, ROUND ALL FLEECE CORNERS.

EXISTING IN-PLACE ALSAN FULLY REINFORCED LIQUID MEMBRANE (SEE NOTE #2).

AREA OF DAMAGED MEMBRANE REMOVED

4" MIN.
